## Why Pavement Preservation?

National Partnership to Determine the Life Extending Benefit Curves of Pavement Preservation Techniques (MnROAD/NCAT Joint Study – Phase II)

## **PG Study Test Sites**

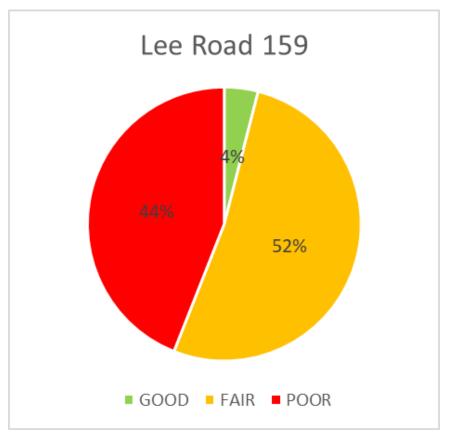
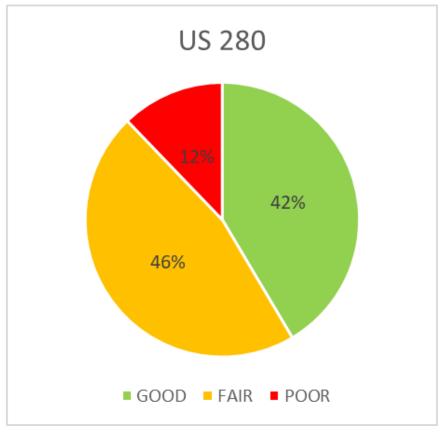
## **Current Cracking**

- Cracking is predominant distress in Southern sections
- Mostly wheelpath cracking
  - **□** Lee Road 159 has more alligator cracking pattern
  - **□** US 280 is longitudinal
- Low severity

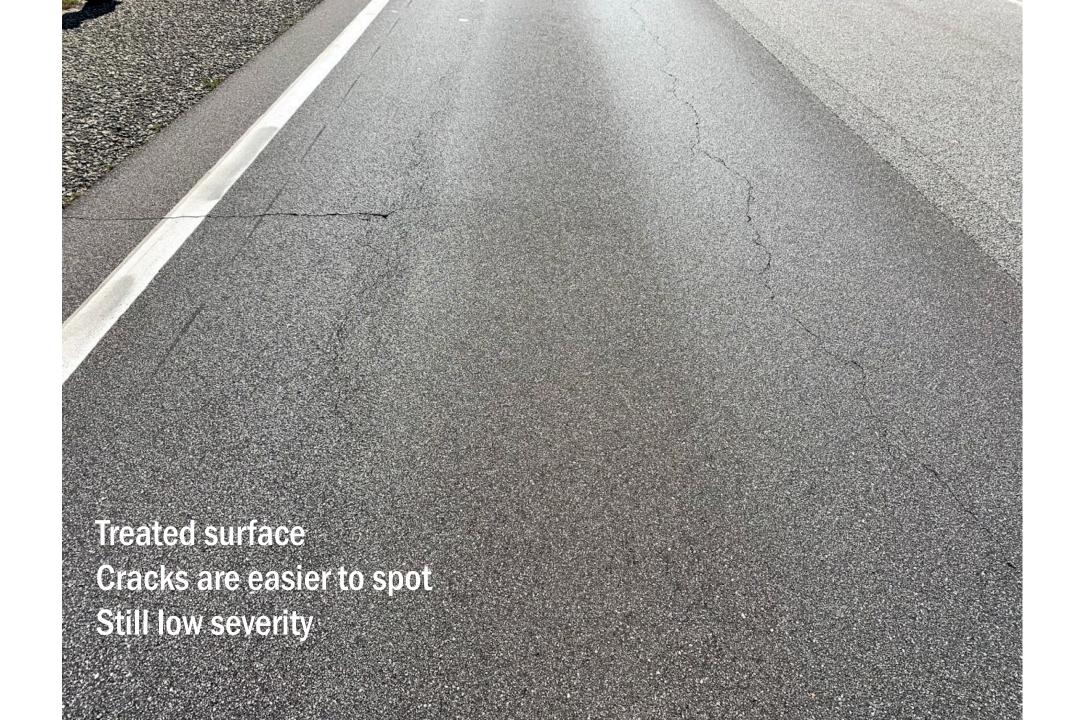
Cracks routed & sealed in 2012

No sealant damage observed

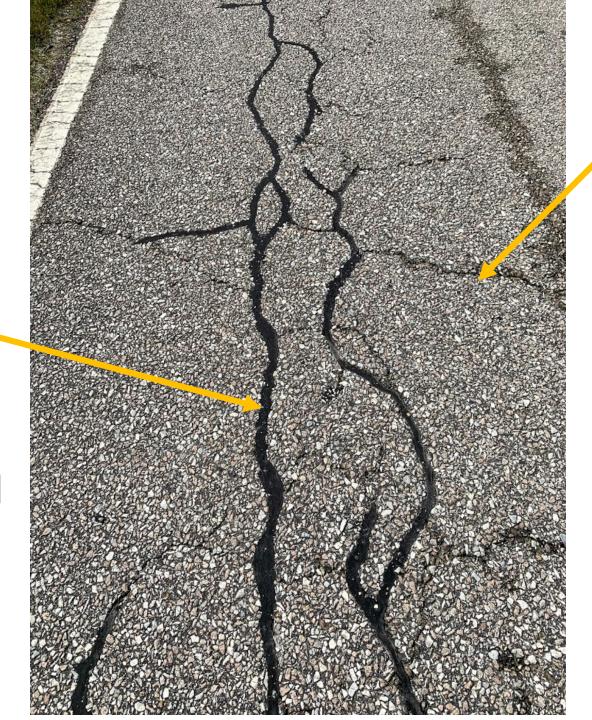
## **New cracks**

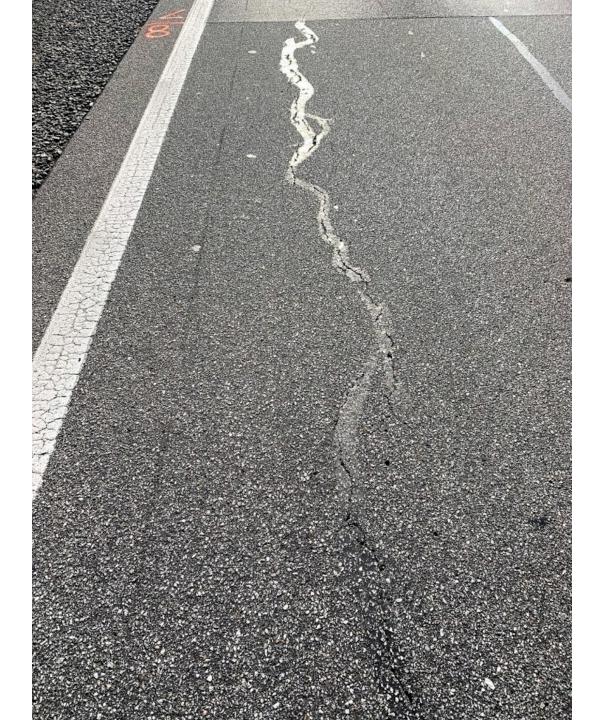
# Overband filled Cracks are visible again, but still tight

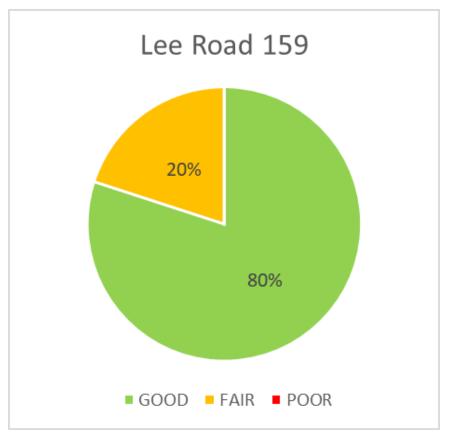
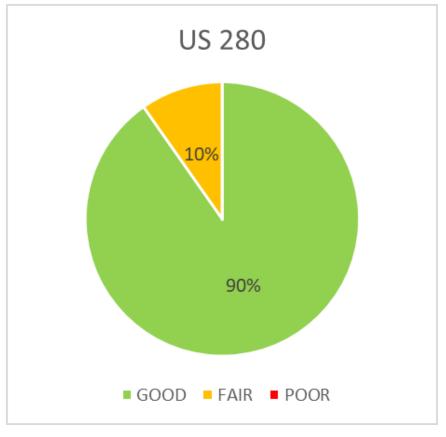
## **Current Rutting**

- Sections had low rutting pre-treatment
- □ Several sections are "borderline" fair (~ 5 mm)

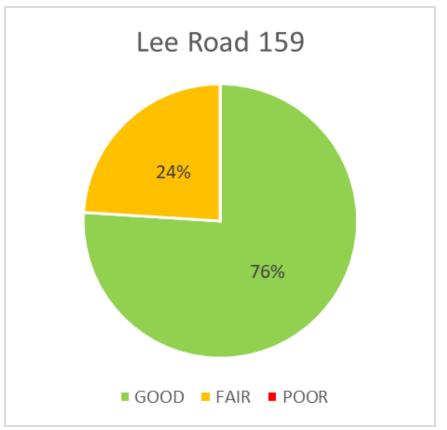
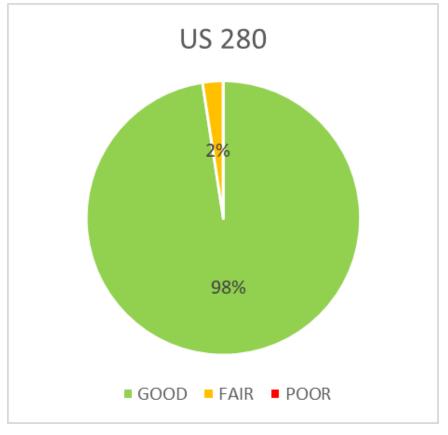
## **Current IRI**

- Overall, good ride quality
- Higher IRI related to shorter sections
  - **□** Affects mostly Lee Road 159
- In general, constant values over time
