MnROAD
Safe, Smart, Sustainable Pavements Through Innovative Research

NCAT/MnROAD Cracking Group

June 22, 2021

Cracking Group Experiment

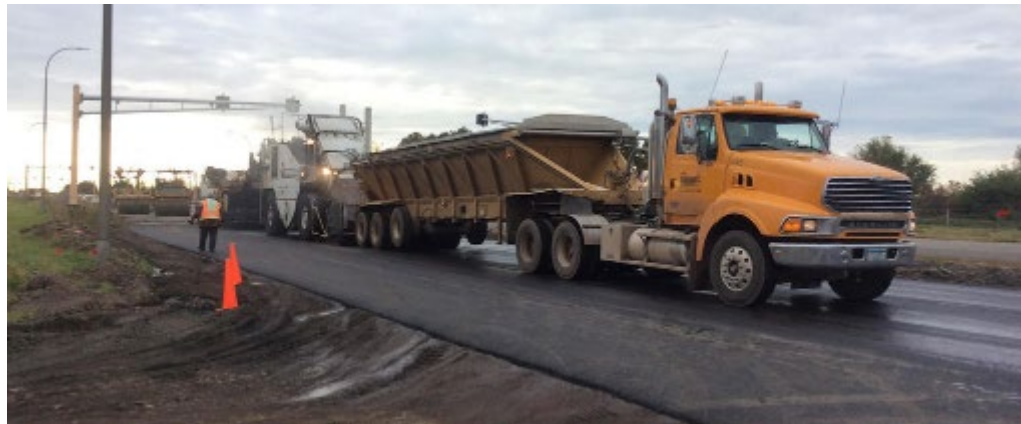
Constructed Section Typical

- HMA paved in 2 lifts
- All lifts and shoulders paved with same mix in each cell

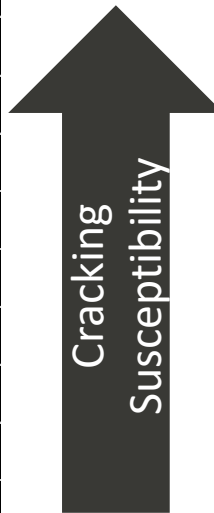
Mixture Overview

- Mixtures selected to achieve range of low-temperature cracking (LTC) potential
 - Based on input from pooled-fund sponsor states
- Contractor selected, procured materials, submitted to NCAT
- NCAT performed mix designs
- Contractor produced/placed mixture

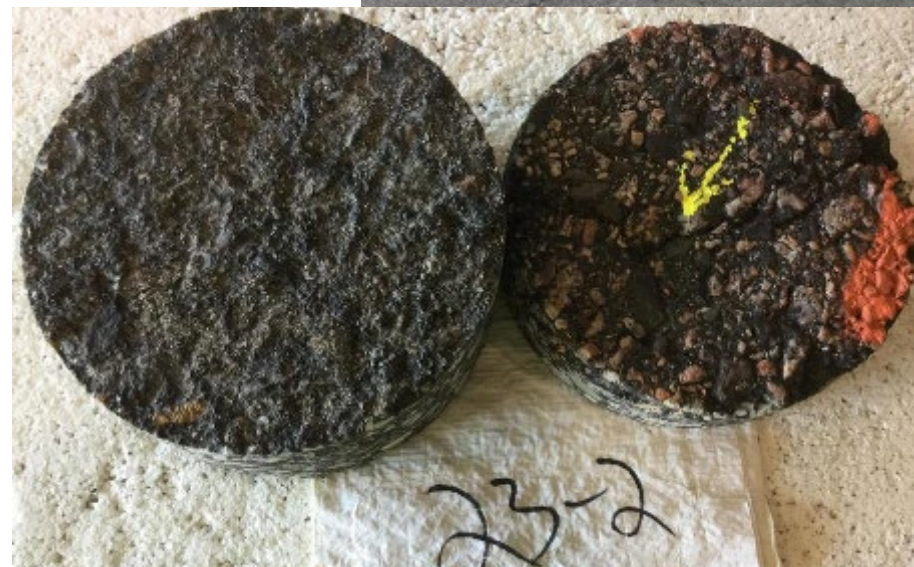
Performance – Cell 23

Moderate RAP, Highly mod. binder

- Largest amount of load related distress
- Delamination under surface lift (2/3 cores)
- Lower lift has no signs of distress in cores

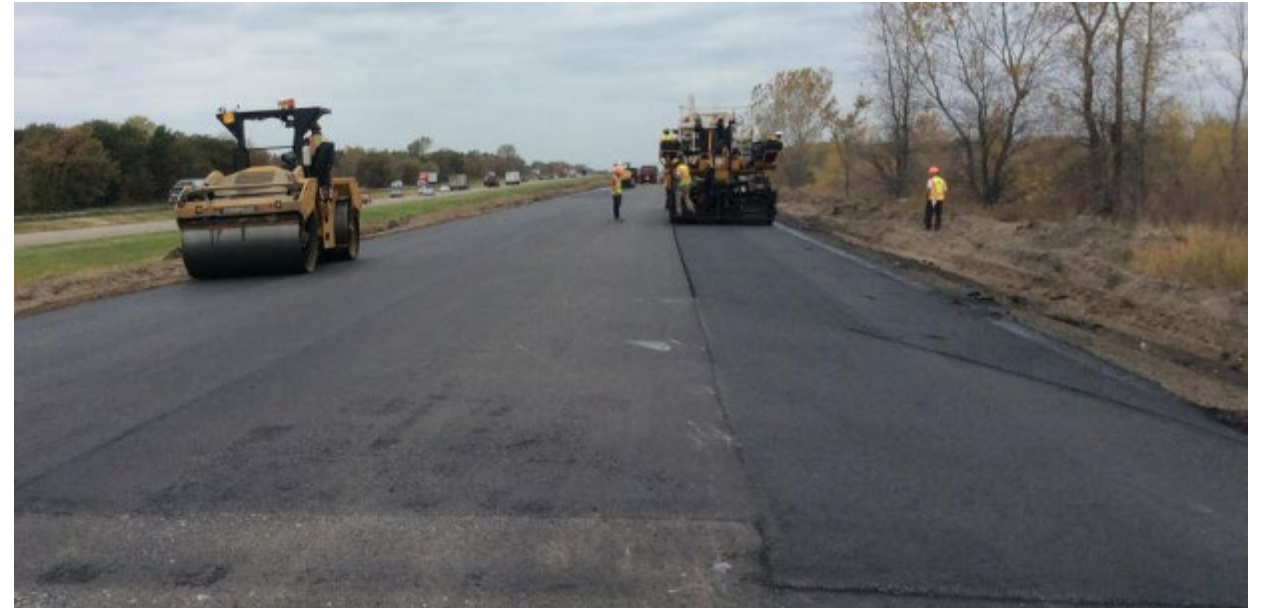
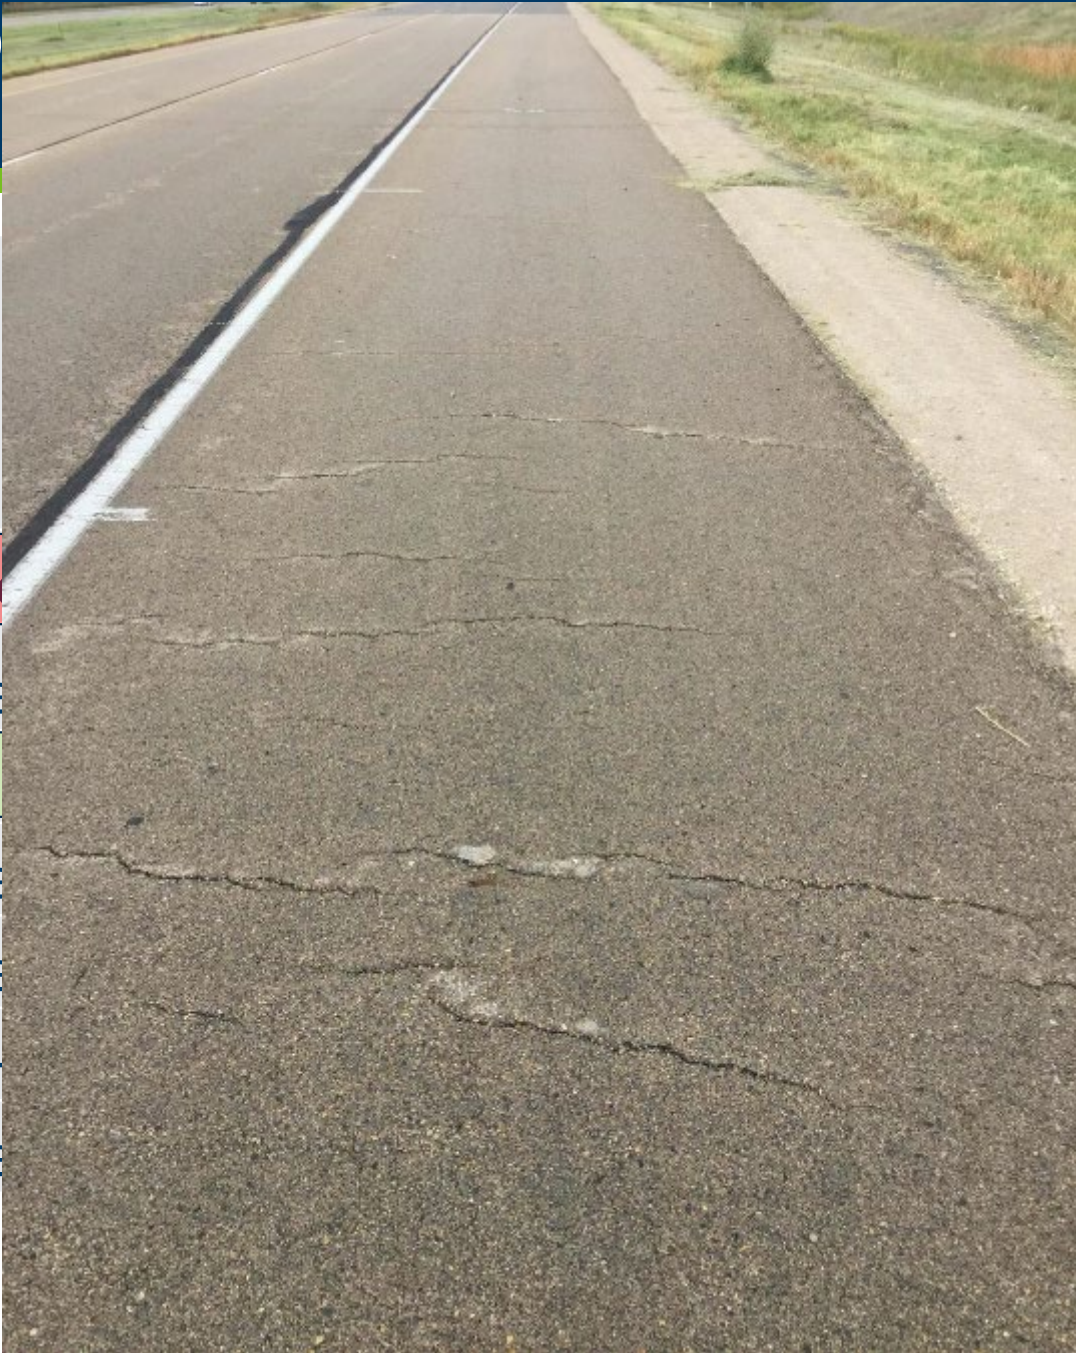
Low Temperature Cracking Analysis

- Need to observed LTC without confounding influence of traffic loading
- Driving lane shoulder (10') had transverse cracks with little other distress
- Shoulders paved with same lifts and thicknesses as entire Cell
- Visual distress survey on shoulders

22	Limestone
21	Moderate
20	High RAP,
19	Moderate
18	Moderate
17	Low RAP
16	Moderate

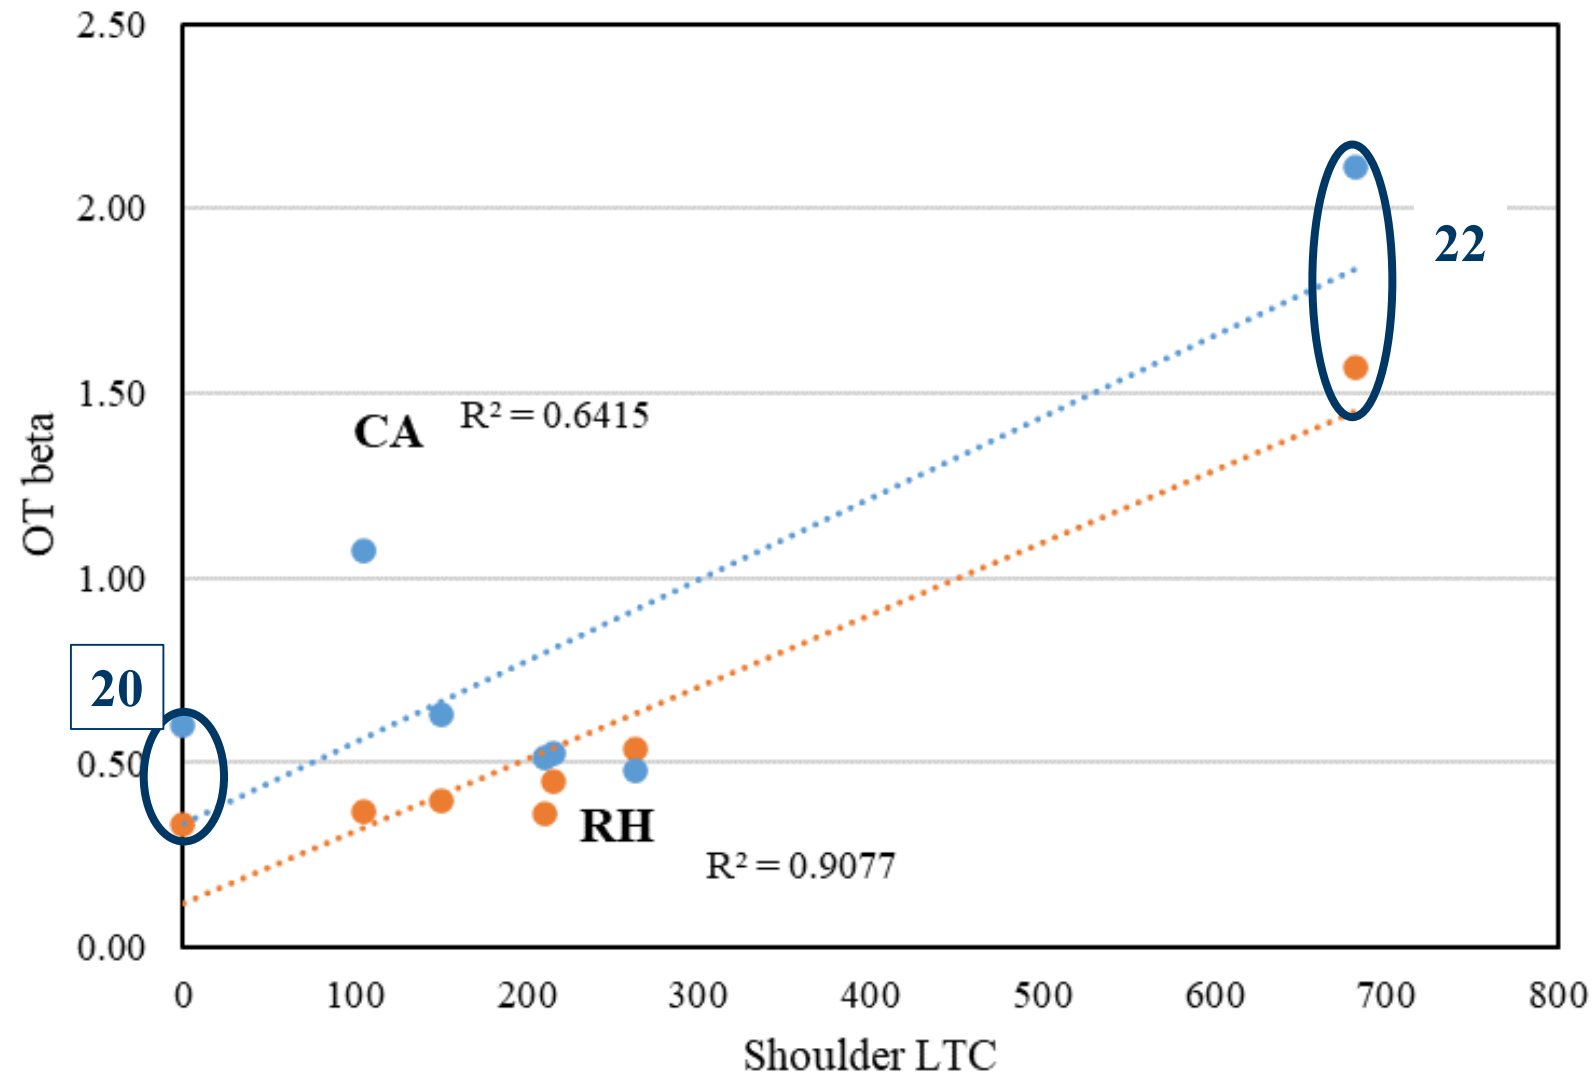
Correlation to Thermal Cracking in Shoulder

Test	R ²	
	RH	CA
DCT Fracture Energy	0.68	0.93
IDT Creep Compliance & Strength	0.04	0.36
Low Temp. SCB-Fracture Energy -12°C	0.47	NA
Low Temp. SCB-Fracture Energy -24°C	0.76	NA
UTSST	0.39	0.27*
IDEAL-CT	0.29	0.52
I-FIT	0.06	0.67
NCAT OT(10°C)-Nf	0.95	0.16
NCAT OT(10°C)-β	0.91	0.64
ACCD	0.21	0.18

Best correlations highlighted in red, $R^2 \geq 0.67$
