Structural Contribution Of Recycled Sections On
Lee Road 159 And US 280

SEVENTH
RESEARCH CYCLE

NCAT TEST TRACK CONFERENCE

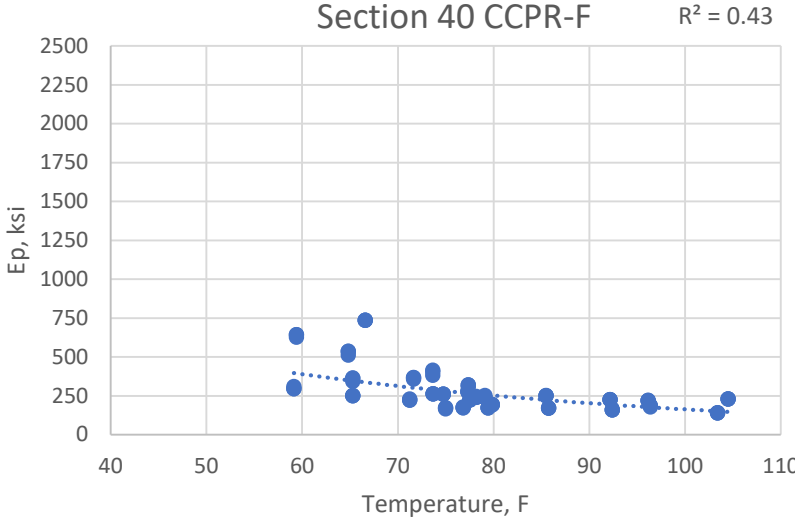
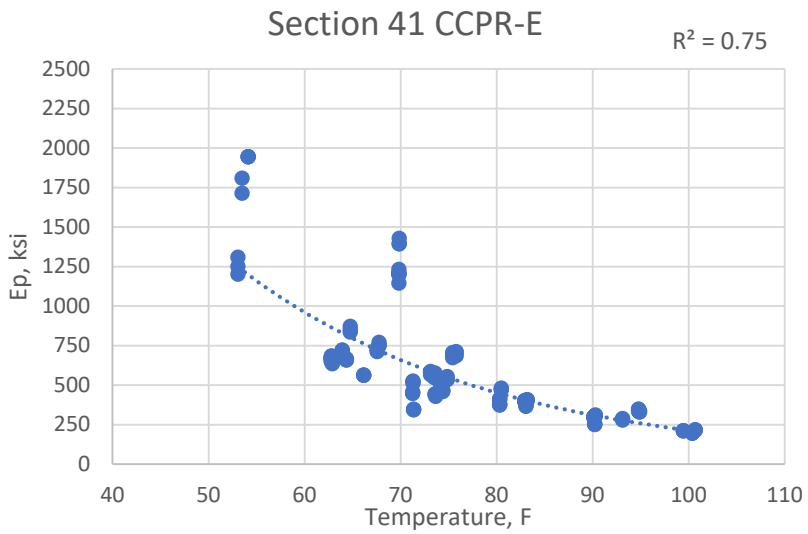
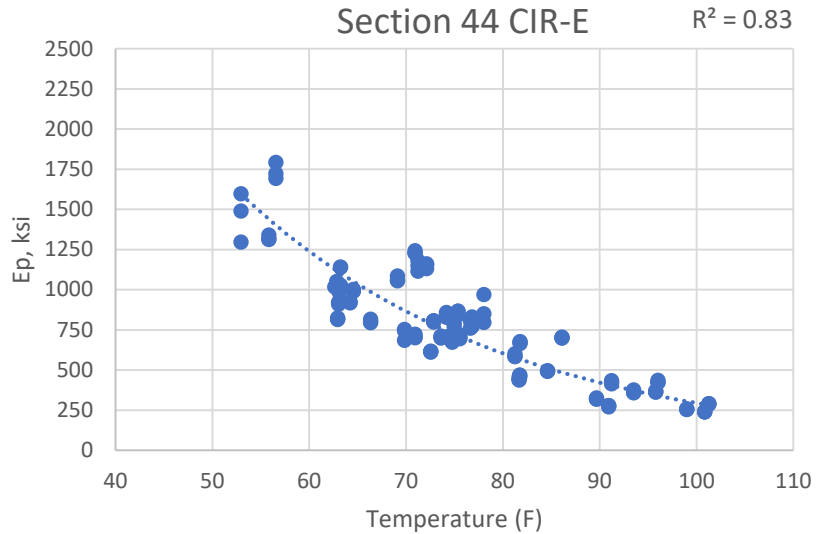
Composite Modulus – US 280

Used ELMOD 6 for backcalculation

Combined all bituminous materials into one layer

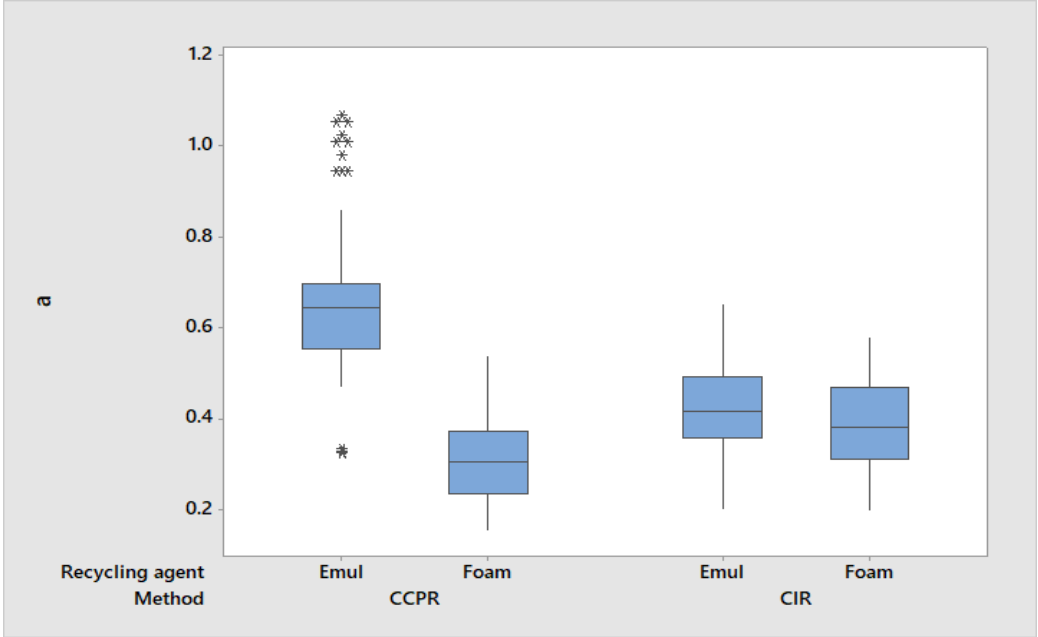
Structural Coefficients – US 280

Section	Method	Recycling agent	N	Average	Std. Dev.
U40	CCPR	Foam	84	0.31	0.092
U41	CCPR	Emulsion	125	0.66	0.154
U43	CIR	Emulsion	126	0.43	0.092
U44	CIR	Foam	126	0.38	0.103

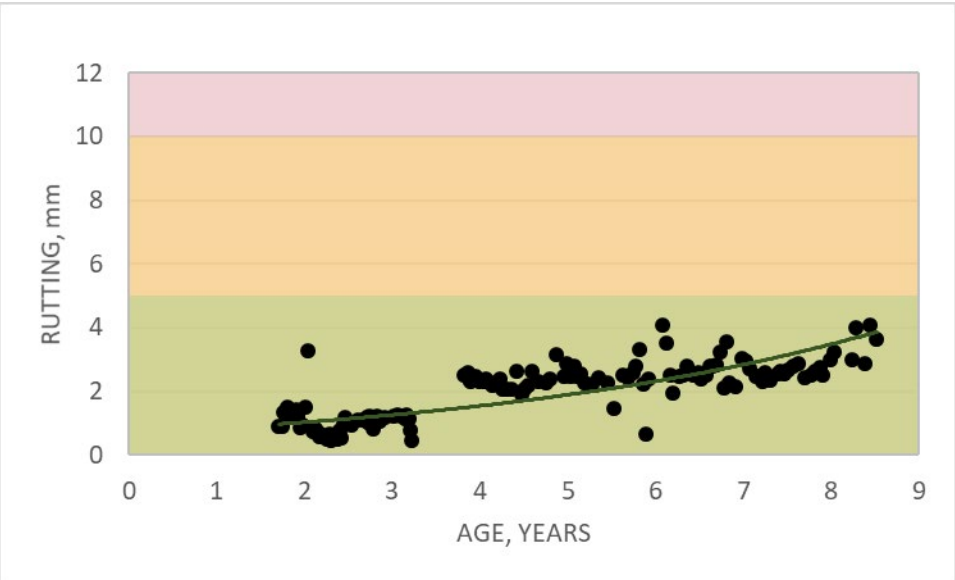
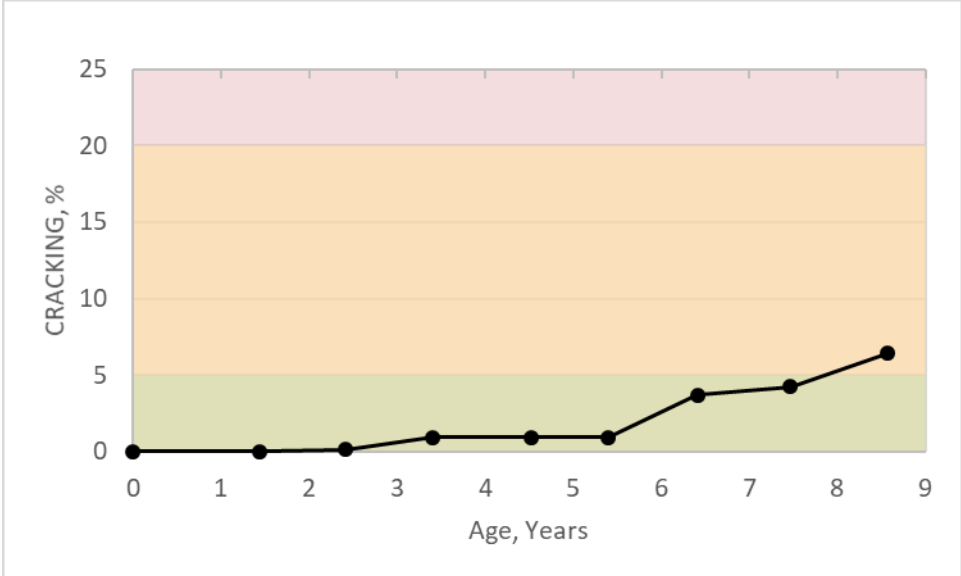
Field Performance – Lee Road 159

Section	Description	Rutting (mm)	IRI (in/mi)	Cracking (%)
L20	Foamed CCPR	3.6	130.7	6.4
