Structural Benefit Of Preservation

Adriana Vargas, PhD

SEVENTH
RESEARCH CYCLE

NCAT TEST TRACK CONFERENCE

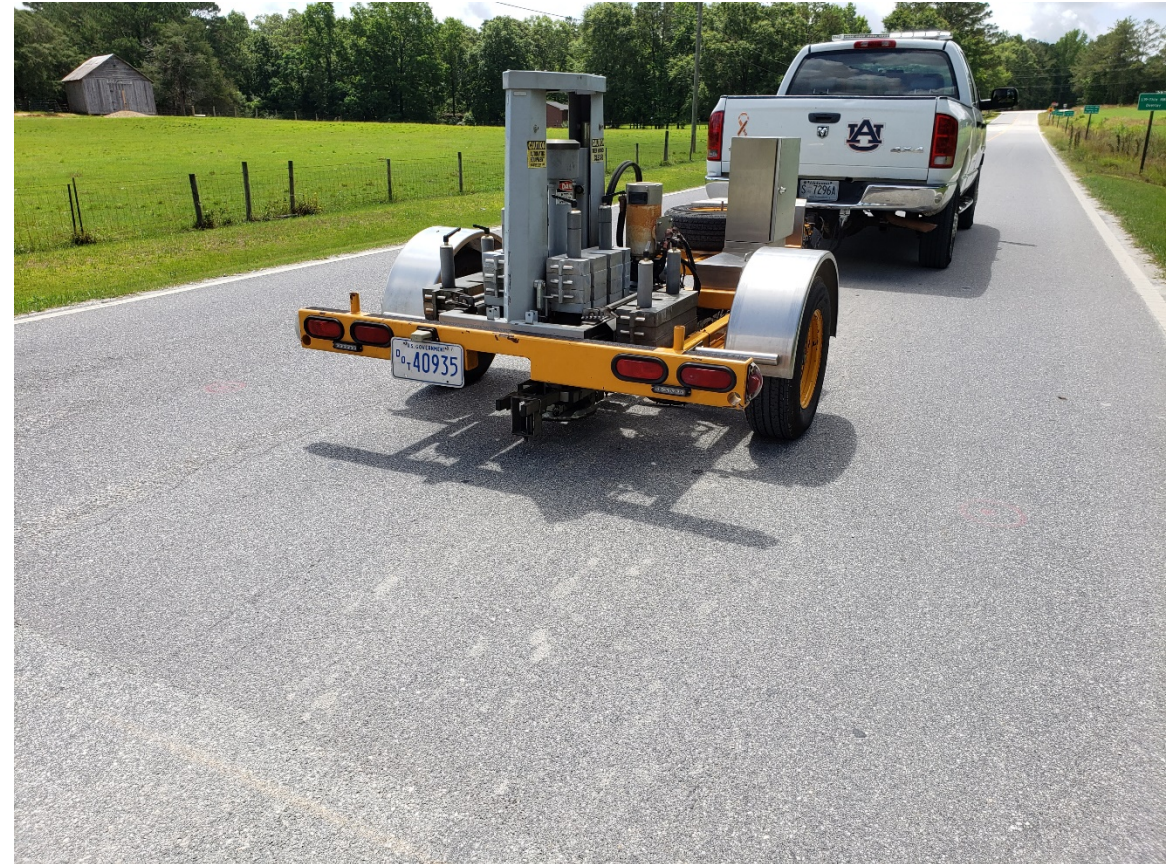
- FWD testing performed periodically
- Lee Road 159
 - ▣ 2012 – 2018 monthly
 - ▣ Since 2018 quarterly
 - ▣ 2 random locations per section in each lane
- US 280
 - ▣ Quarterly
 - ▣ 3 random locations per section
- US 169 & CSAH 8
 - ▣ 3 times per year
 - ▣ 3 random locations

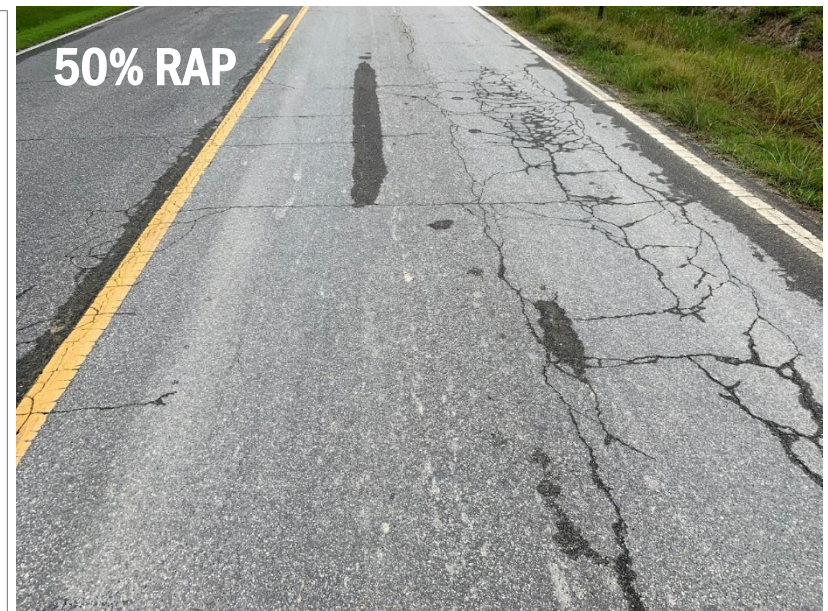
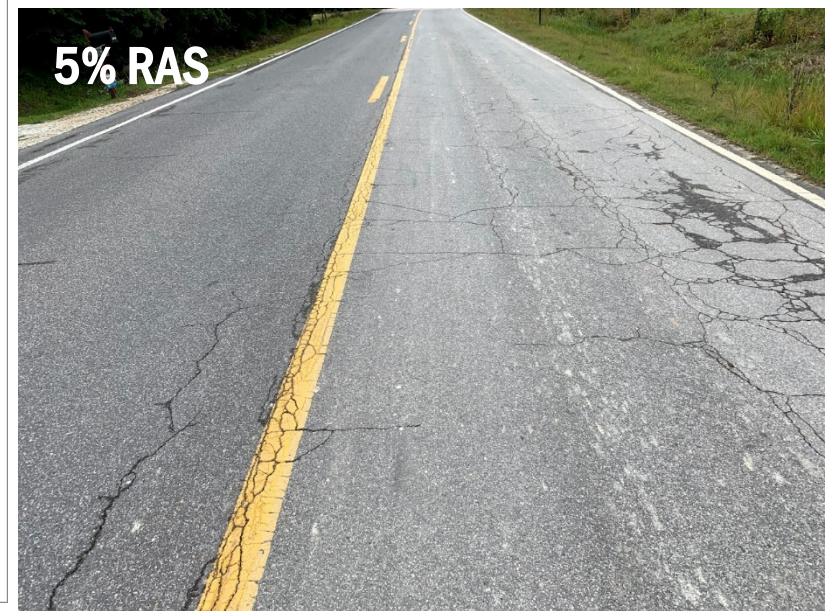
Results - Example

- Will use thin overlays to illustrate results
 - ▣ Still functional treatments
 - ▣ All ¾" thick
 - ▣ No milling
- Other treatments show similar trends

Section	Description
Virgin PG 67-22	4.75 NMAS thin virgin overlay with PG 67-22 binder
Virgin PG 76-22	4.75 NMAS thin virgin overlay with PG 76-22 polymer modified binder
UTBWC	12.5 NMAS Ultra-thin bonded wearing course placed with spray paver with PG 76-22 polymer modified binder
50% RAP	4.75 NMAS thin overlay with 50% fractionated recycled asphalt pavement (RAP)
5% RAS	4.75 NMAS thin overlay with 5% post-consumer recycled asphalt shingles (RAS)
HiMA	4.75 NMAS thin virgin overlay with high polymer modified binder (7.5% SBS)

- May see a small effect following treatment
- Long term – treated sections deteriorate at a lower rate
- Improved surface condition
- Correlation between cracking / rutting and BDI / BCI
- Time in service and testing frequency not enough for forecasting in locations other than Lee Road 159
 - ▣ Still similar trends

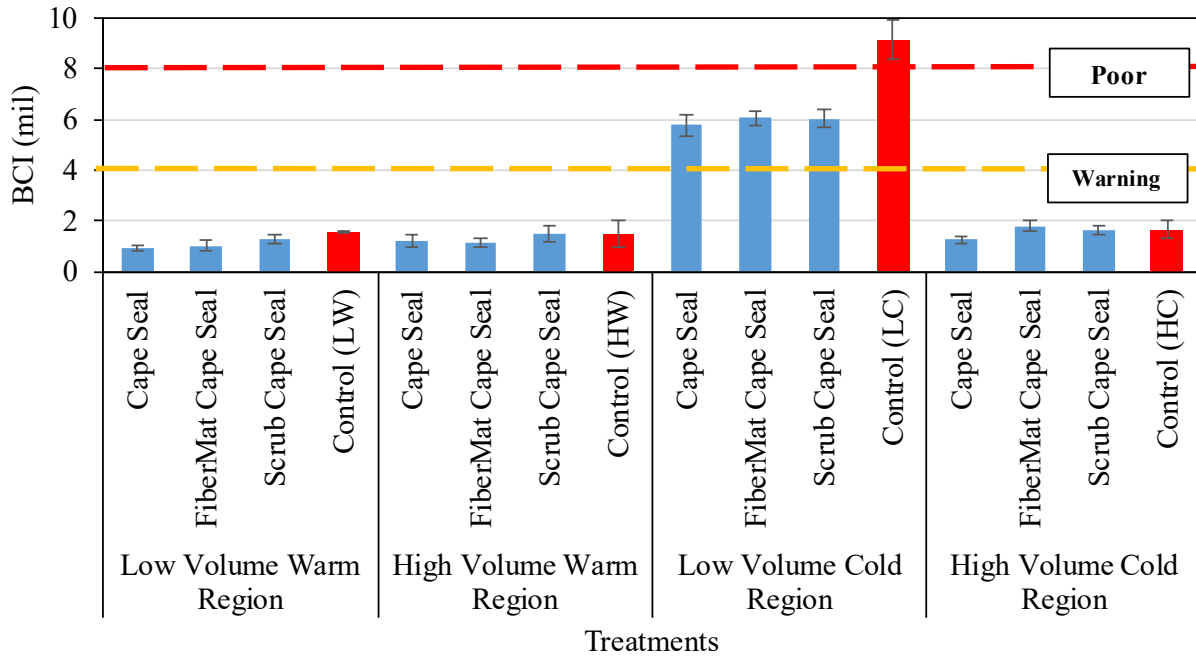
□ Cape seals - current condition
