Quadrant: S
Section: 8A

Research Objective: Effect of Low QC Air Voids on Rutting

Quadrant: S
Section: 8B

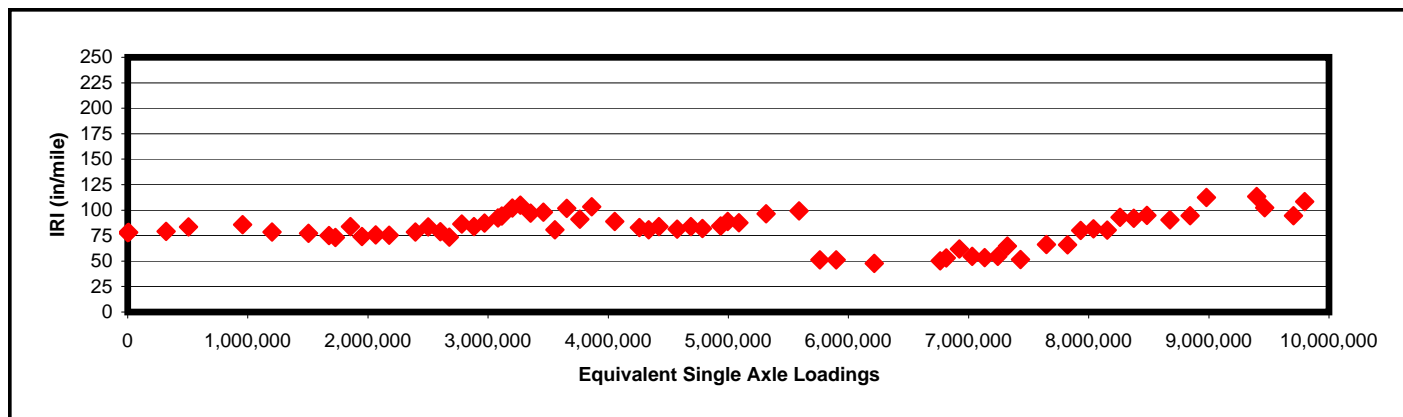
Preliminary Field Performance Data

Year of Completion: 2006
 HMA Design Methodology: Superpave
 Specified Binder: PG64-22+
 Surface Mix Stockpile Materials: Granite/Limestone/Sand

Study HMA (in): 2
 Total HMA (in): 24
 Base Material: Granite
 Subgrade: Stiff

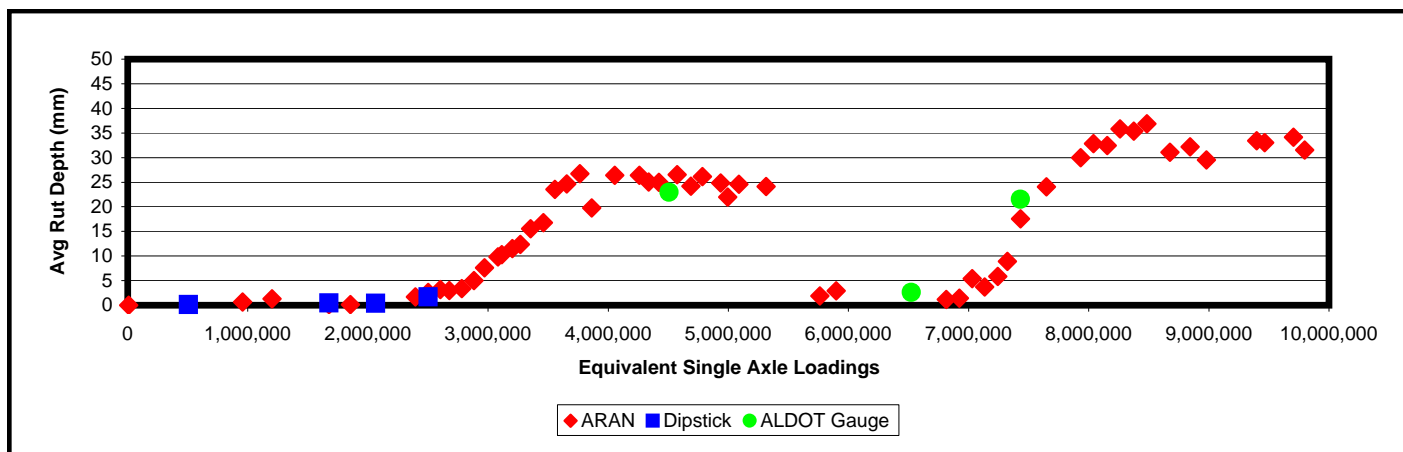
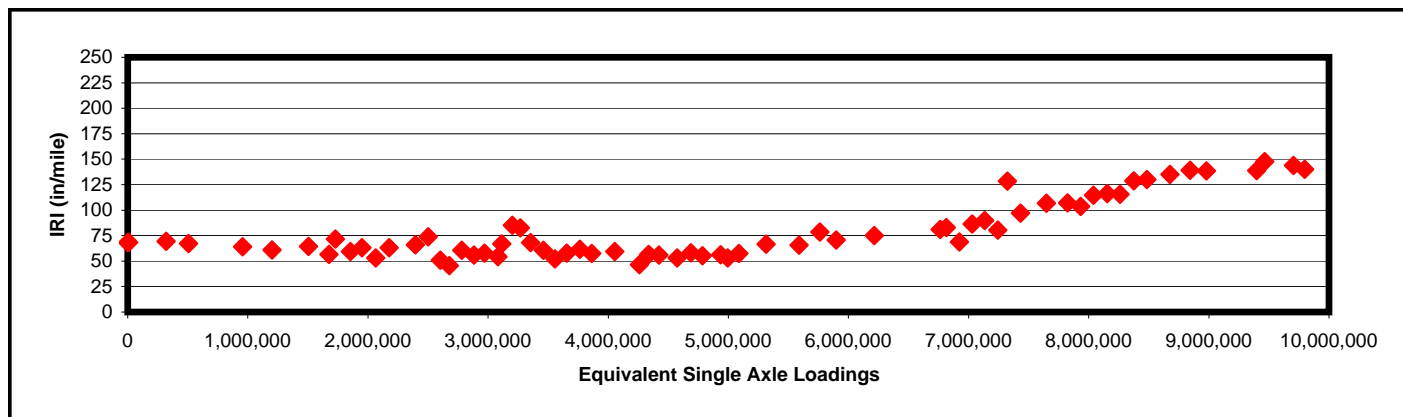
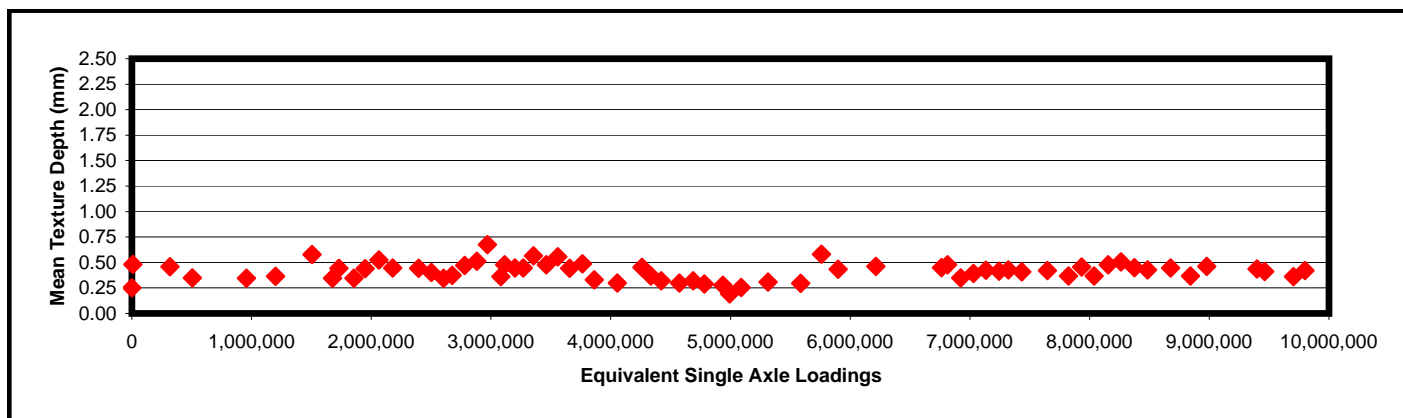
Preliminary Field Performance Data

Year of Completion: 2006
 HMA Design Methodology: Superpave
 Specified Binder: PG64-22+++
 Surface Mix Stockpile Materials: Granite/Limestone/Sand

Study HMA (in): 2
 Total HMA (in): 24
 Base Material: Granite
 Subgrade: Stiff
